Quality Assurance and Source Inspection

WELDING INSPECTION REPORT

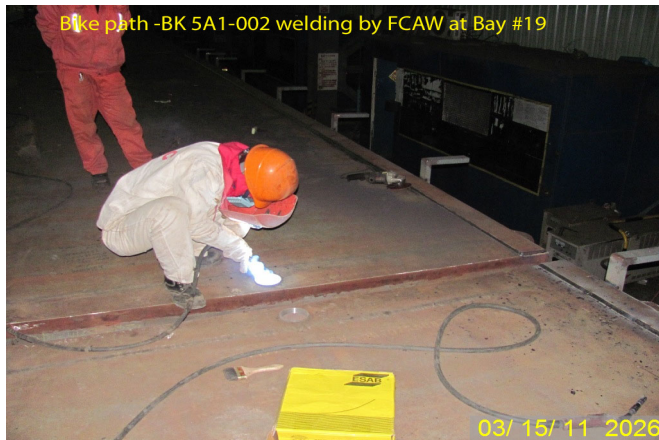
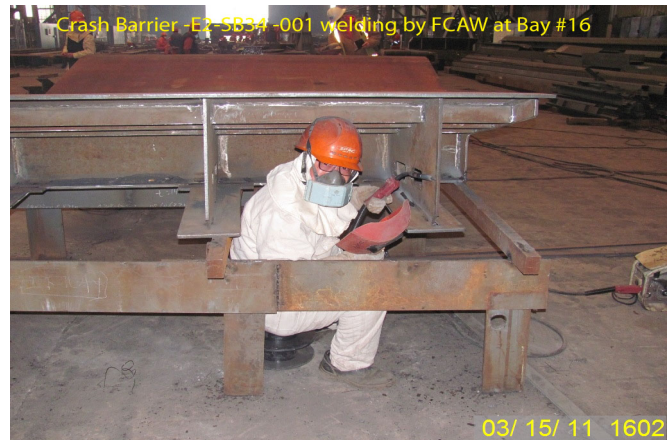
For further information see below pictures:-

Unless otherwise noted, all work observed on this date appeared to be in general compliance with the applicable contract documents.
